# Manhole Inspection Summary

Manhole # S39Y1\_033MH

**Location** Address: **3701 5th Street**

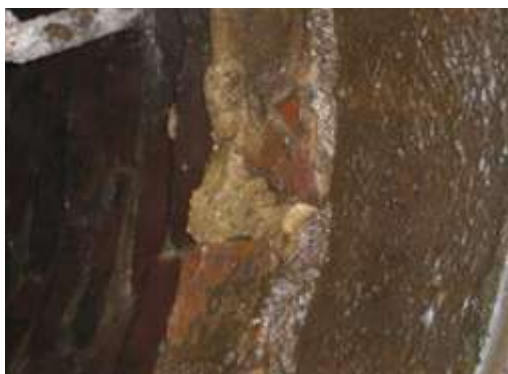
Defect 1

Infiltration: ☐ None ☐ Joint ☐ Cracks ☒ Mortar ☐ Roots ☒ Wall

mortar

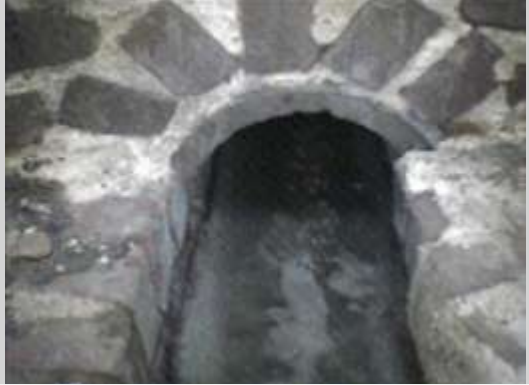
12 O'Clock Outflow

8 in. Circular Gravity Sewer  
Pipe Out @ 12 O'Clock

Pipe Height: **8.4** (in.) Rod and Bar (Angled)  
Pipe Material: **Clay** ☐ Pipe Lined  
Invert Depth: **10.18** (ft.) Flow Characteristics: **Slow**  
Deposits: ☒ None ☐ Mud ☐ Sludge ☐ Debris ☐ Grease  
Silt Depth: (in.) Deposits Extent:  
Infiltration: **None** Pipe Seal Cond: **Sound**

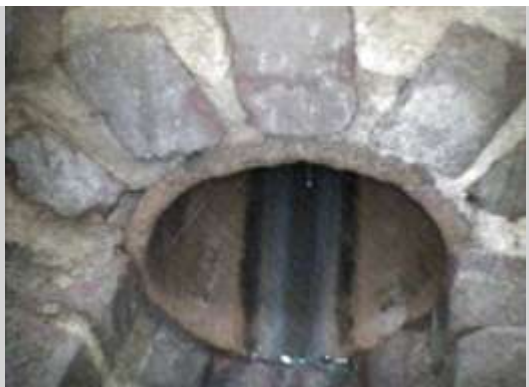
3 O'Clock Inflow

8 in. Circular Gravity Sewer  
Pipe In @ 3 O'Clock

Pipe Height: **8.4** (in.) Rod and Bar (Angled)  
Pipe Material: **Clay** ☐ Pipe Lined  
Invert Depth: **9.60** (ft.) Flow Characteristics: **Slow**  
Deposits: ☒ None ☐ Mud ☐ Sludge ☐ Debris ☐ Grease  
Silt Depth: (in.) Deposits Extent:  
Infiltration: **None** Pipe Seal Cond: **Sound**
